## Facing a Grilling

Once upon a time, in a town right on our doorstep, there was once a bank. Designed by a renowned architect R.A Lawson, it was a stately building that had the presence and formality that befitted its occupation.

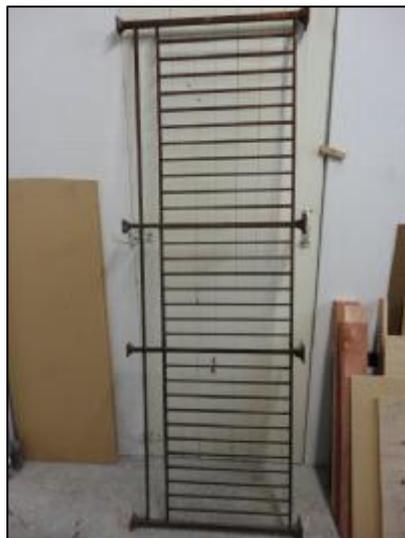
The grill, along with its accompanying wooden panel, was found buried away in the back of a shed. All the neglect meant it was very rusty, making it hard to tell exactly what sort of condition it was in underneath.

The grill before restoration work began.

The museum's restorers began the long process of returning the grill to its original condition. Due to the corrosion, a sophisticated electrolytic rust removal technique was used. This method is commonly used by museum conservators to recover original finishes on ferrous objects.

The scum on surface of the tank is the rust, whale oil hinge lubricant, grime and the shellac coating which was used to protect the surface finish when it was first made.

Once removed from the tank the waste electrolyte material was washed off the grill and it was dried.

Time was then spent wiping the surface with fine steel wool, after which it was coated with microcrystalline wax and polished with a soft cloth.

Much to our delight around 85% of the original copper finish remained when we only expected 10%.

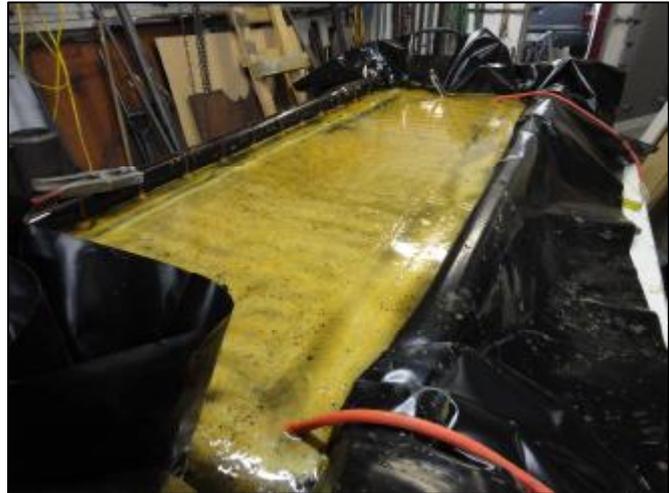
Once returned to its pristine condition, the grill was put back in its rightful home.

Period screws were used to attach the grill back into its original position above the bank counter. The wooden panel was cleaned and a wax polish applied before it was re-affixed to the counter, at the left hand end.

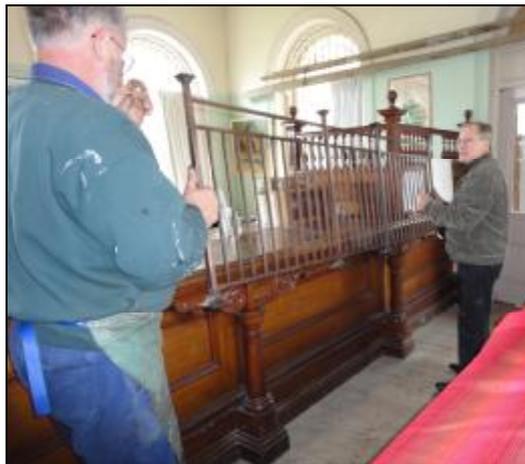
Back in the gold rush days the hinged central panel enabled bags of gold and other hefty items to be passed through the grill to be stored safely in the vault. (The original vault is also still in place.)
